Field survey on tire inflation of
M1 vehicles - May 2018

DEKRA Test Center reference : 17T&E11-149

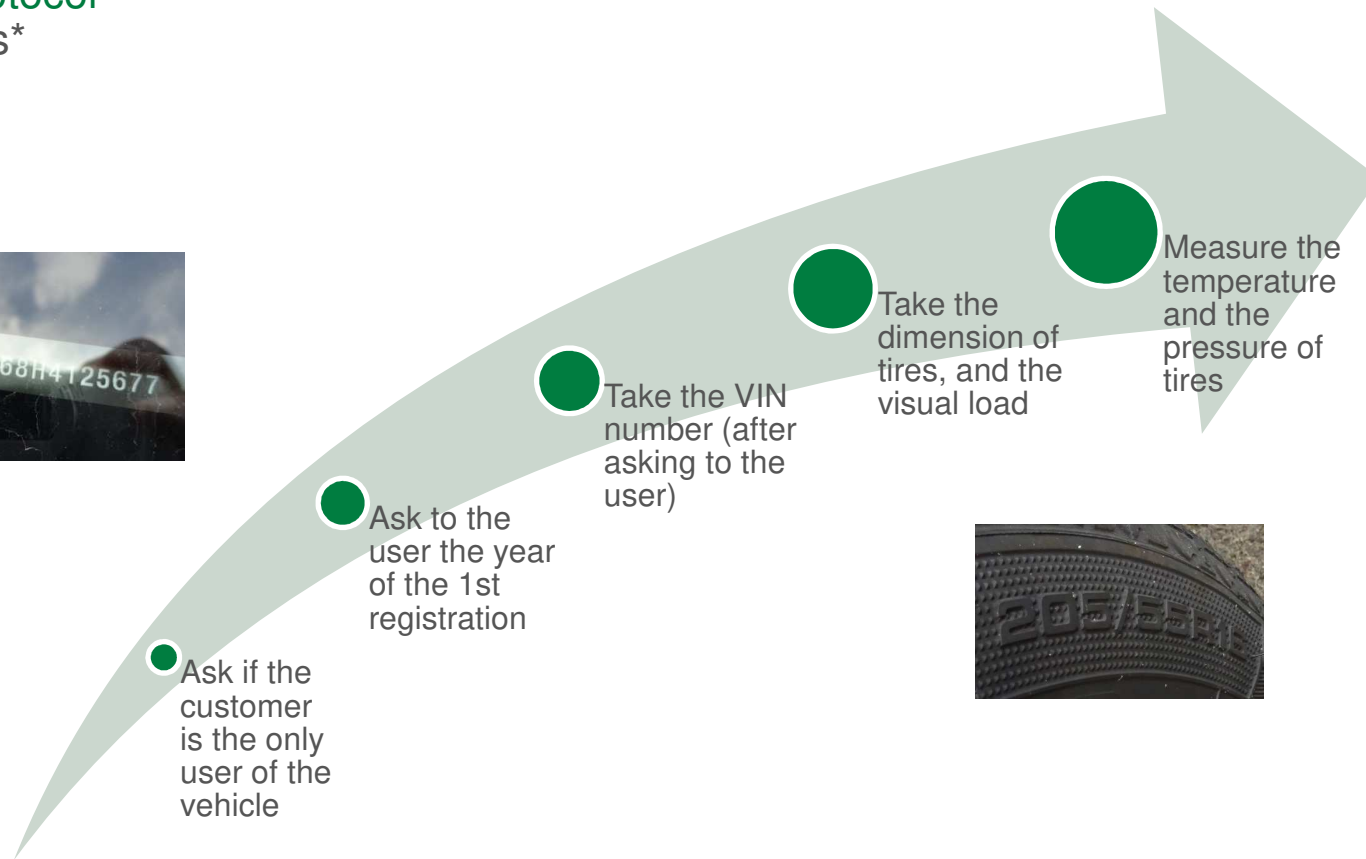
Test protocol Process*

*The process applied by DEKRA Test Center for the survey was discussed, adapted and approved by T&E.

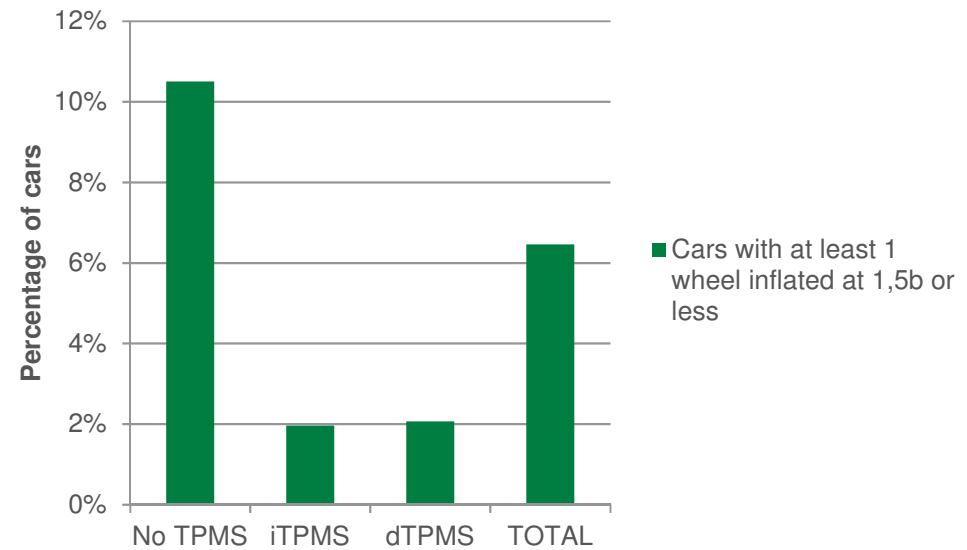
Cars with at least 1 wheel inflated at 1,5b or less
No TPMS	11%
iTPMS	2%
dTPMS	2%
TOTAL	6%

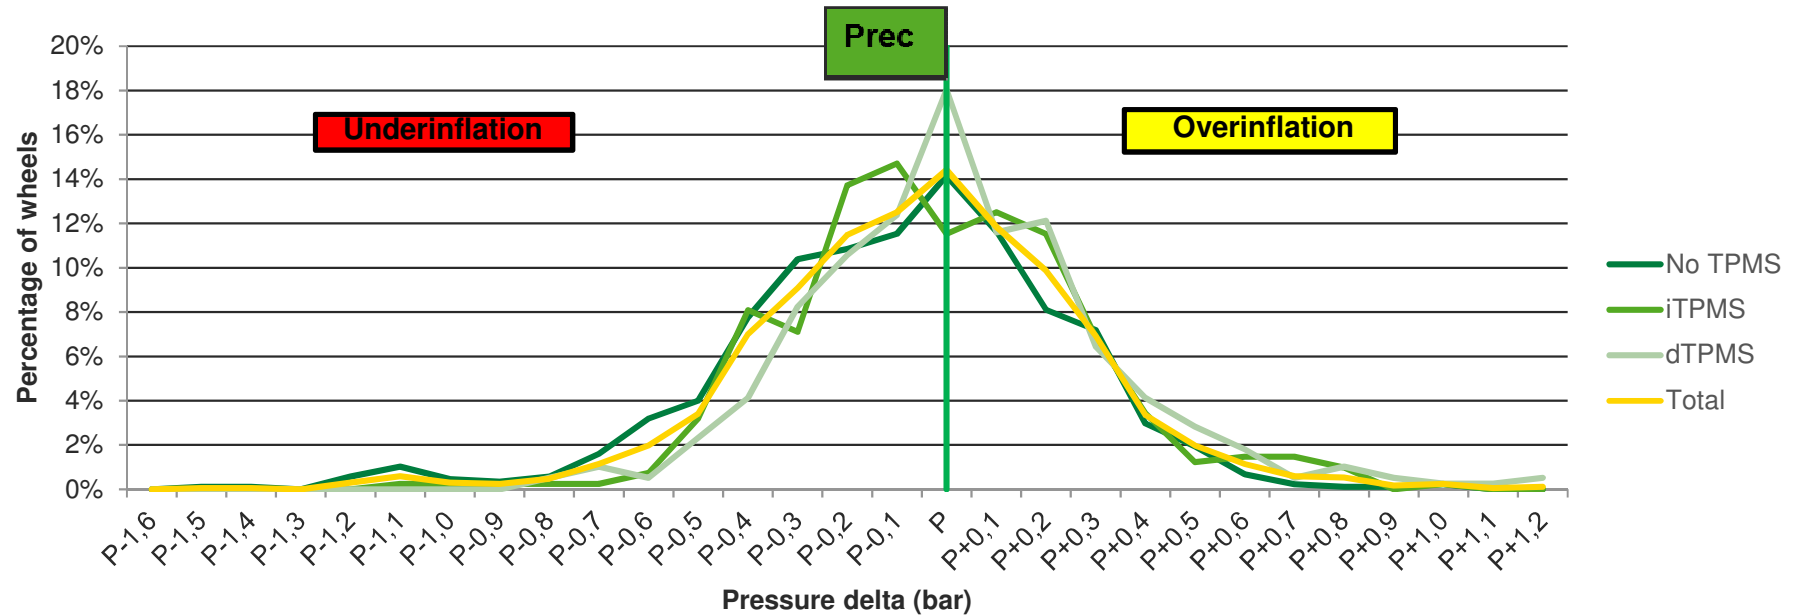
Distribution of tire pressure per wheel

Pressure delta are gathered as follows : $P-0,05b < P < P+0,05b$.

Example : $P+0,4$ gathers pressure delta from $P+0,35$ to $P+0,45$.
